An Assessment of Shore Erosion in Northern Chesapeake Bay

1982

tidewater administration. maryland dept. of natural resources.

AN ASSESSMENT OF SHORE EROSION IN NORTHERN CHESAPEAKE BAY
AND OF THE PERFORMANCE OF EROSION CONTROL STRUCTURES

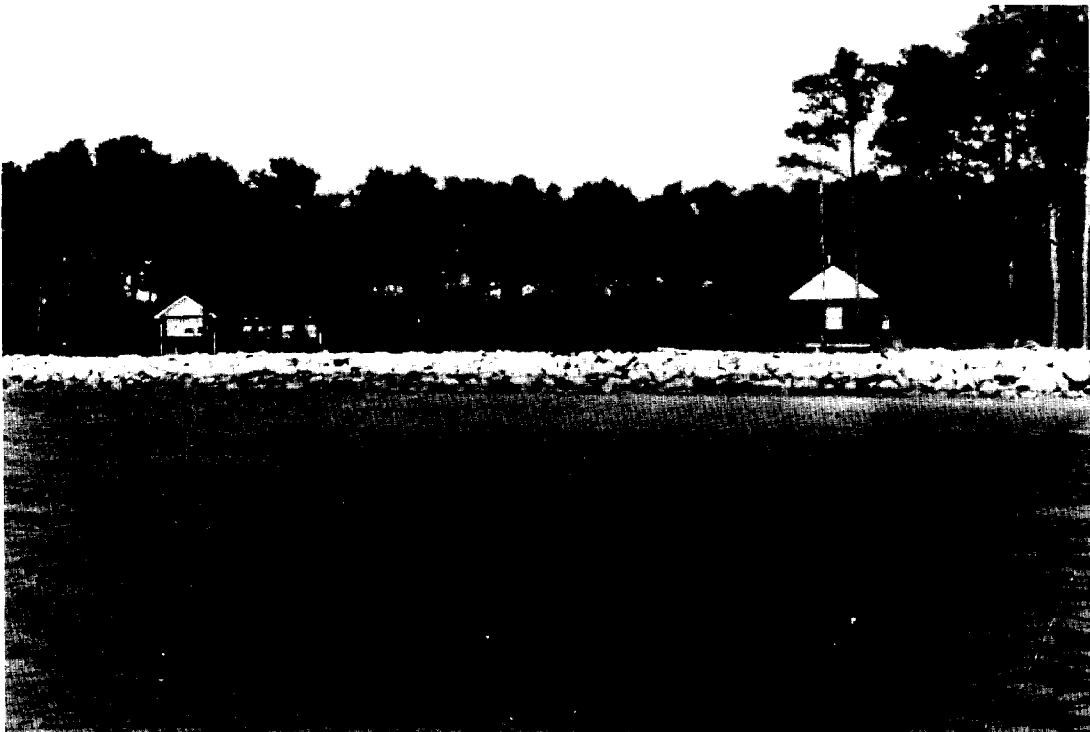
CASE 1 A STONE REVETMENT ON TAYLORS ISLAND

Structure was completed in 1978 at a cost of \$84.56/ft. The historical rate of erosion at the site was 10.5 ft./yr. from 1848-1942. Stone revetment, on a 2:1 slope, consists of 400-1200 lbs. stone in a 3 ft.-thick armor layer. A bedding layer 8 in. thick was placed below the armor layer. Bedding layer consists of 3-8 in. stone. Filter material was used below bedding layer. This structure is in generally good condition. Severe erosion and failed structures can be observed directly adjacent to this case.

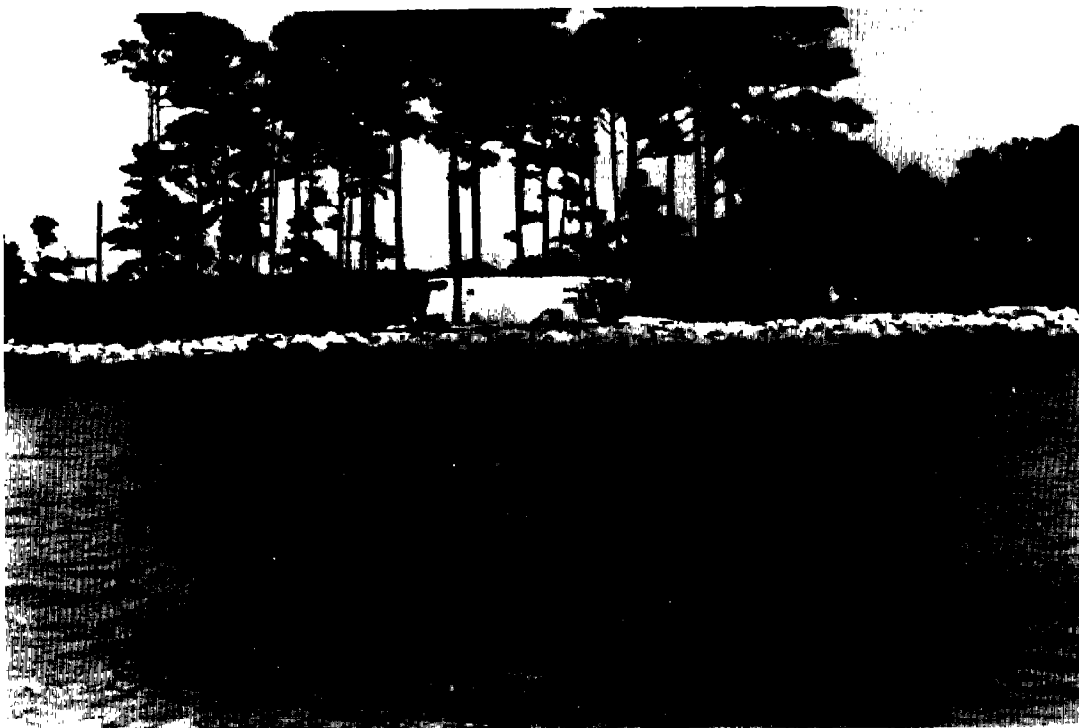
CASE 2 A STONE REVETMENT ON TAYLORS ISLAND

Structure was completed in 1977 at a cost of \$72.82/ft. The historical rate of erosion at the site was 10.5 ft./yr. from 1848-1942. Stone revetment, on a 2:1 slope, consists of 400-1000 lbs. stone in a 3 ft.-thick armor layer, with 8 in.-thick bedding layer. Revetment has m-shaped well-ring structure on seaward side, and connects to a well-ring structure alongshore in one direction. There is flanking erosion alongshore in the other direction. Sand has not been impounded in the lobes of the well-ring wall. This structure is in generally fair to good condition, but is constructed of smaller stone than other revetments along the same shoreline reach.

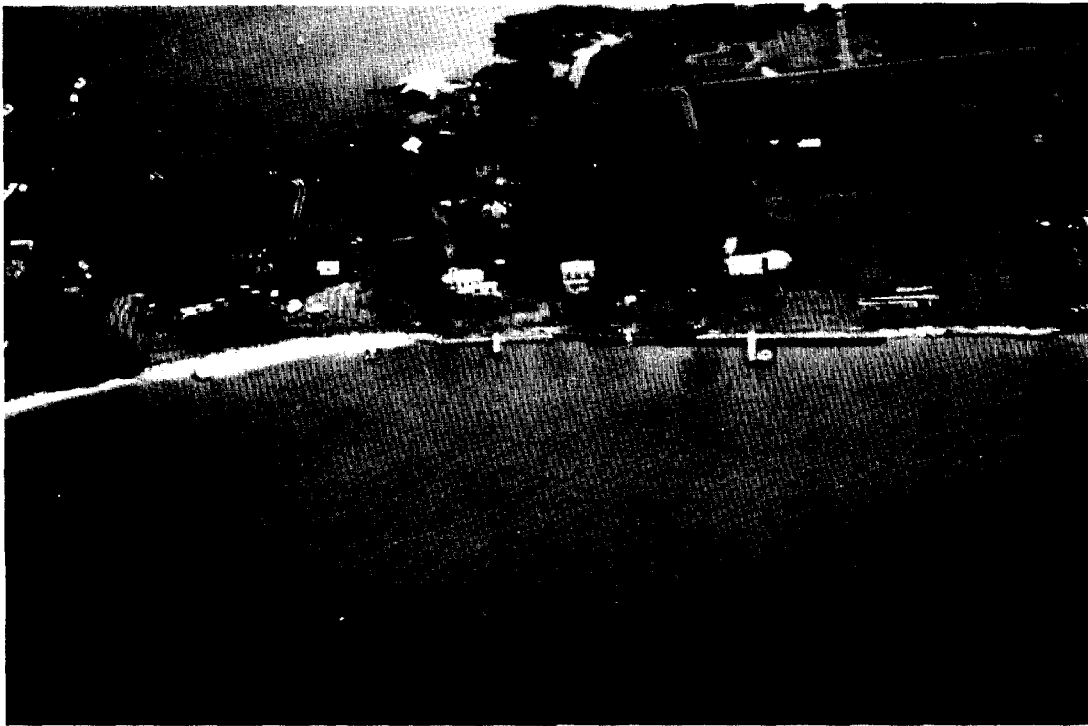
CASE 5 A STONE REVETMENT WITH TWO STONE GROINS IN TAR BAY

These structures are in generally good condition.

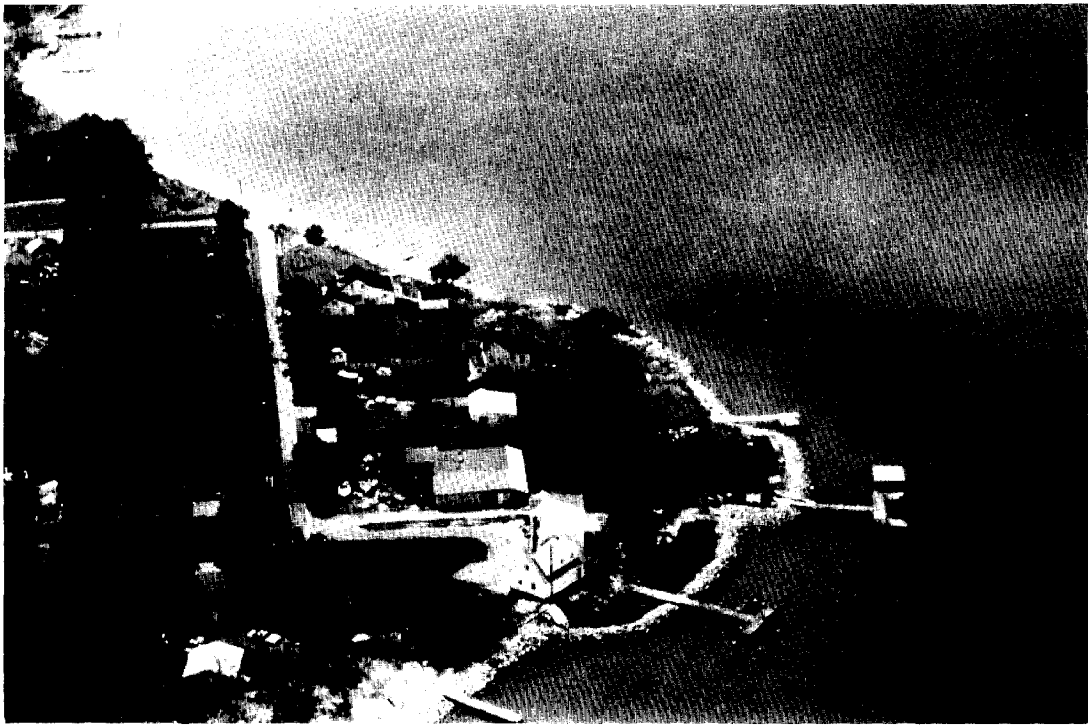
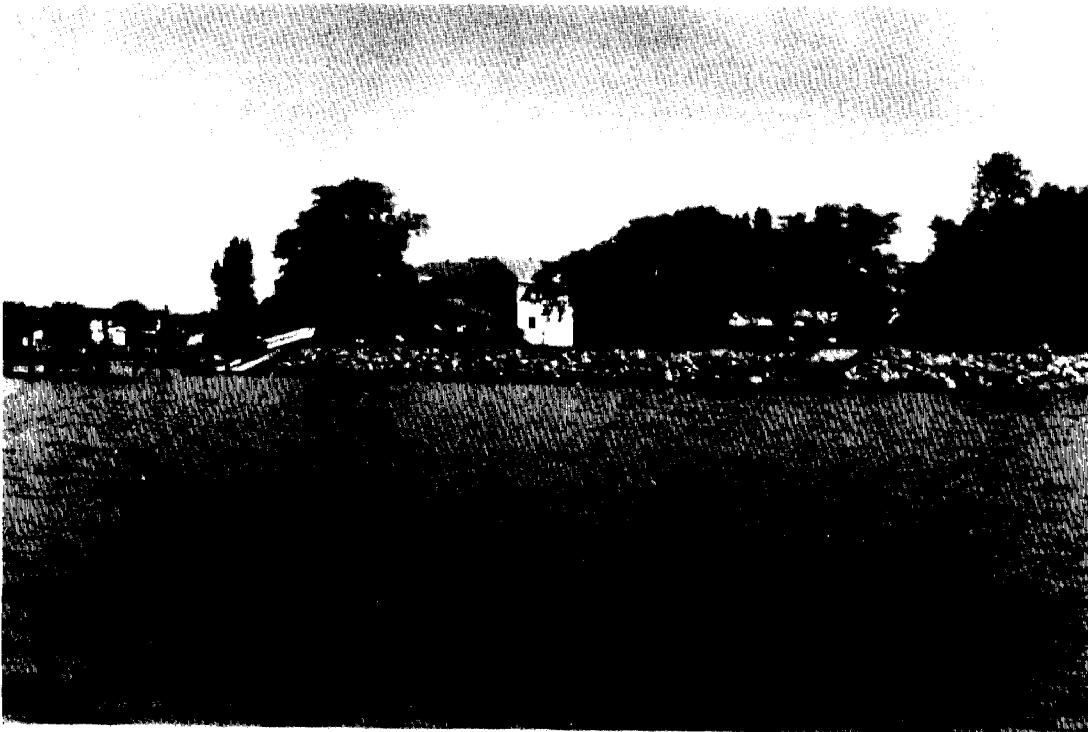
CASE 6 A STONE REVETMENT ON UPPER HOOPER
ISLAND

Structure was completed in 1977 at a cost of \$66.15/ft. The historical rate of erosion at the site was 1-2 ft./yr. from 1848-1942. Stone revetment, on approximately 2:1 slope, is in good condition. This structure fronts several properties, and is doubly-reveted in some portions. Revetment also extends onto the fastland to different heights up to 7.5 feet above MLW, in front of different properties.

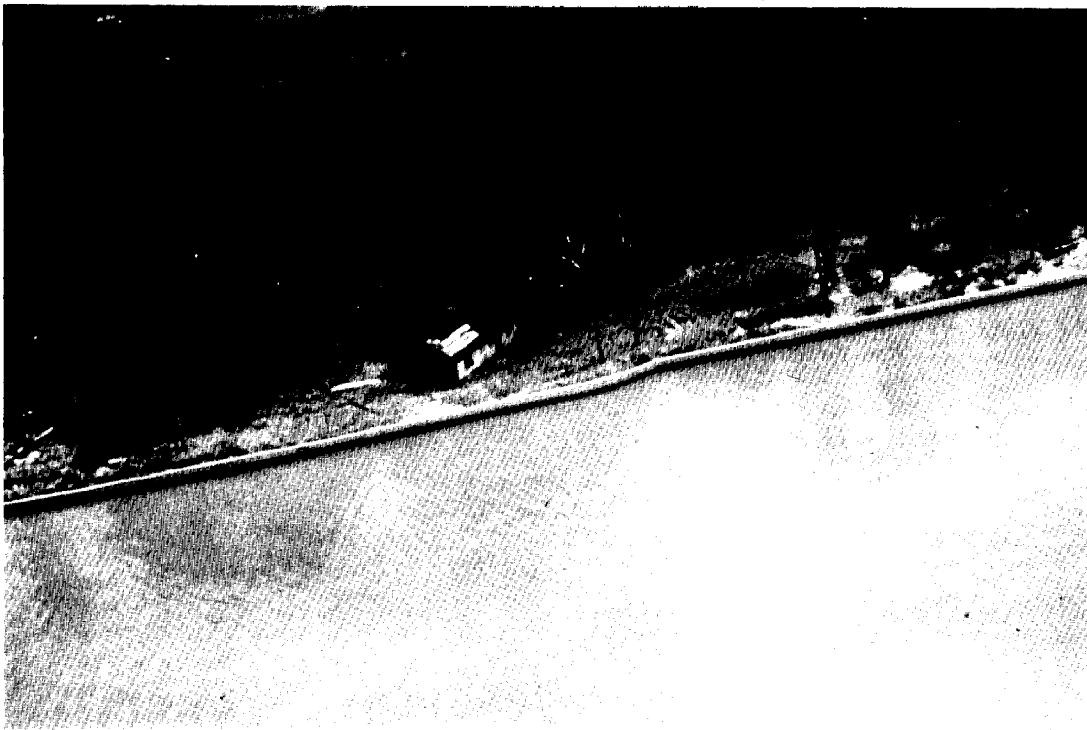
CASE 7 AN ALUMINUM BULKHEAD AT PARKS NECK
ON THE HONGA RIVER

Structure was completed in 1975 at a cost of \$42.50/ft. The historical rate of erosion at the site was 5 ft./yr. from 1848-1942. Bulkhead consists of 103 aluminum corrugated panels, each 4.8 ft. wide, 0.10 in. thick, 8.5 ft. long. Short return walls of at least 14.6 ft. each used at each end have been lost due to flanking. About 50 feet of recession has occurred since emplacement of the structure. Overtopping occurs during storms, and material is being lost through the wall. An inspection report prepared in 1978 indicated (1) failure is due partly to one year delay in backfilling the structure; (2) structure exhibits lack of maintenance; (3) structure may have been partly damaged initially by heavy equipment used during backfill operation.

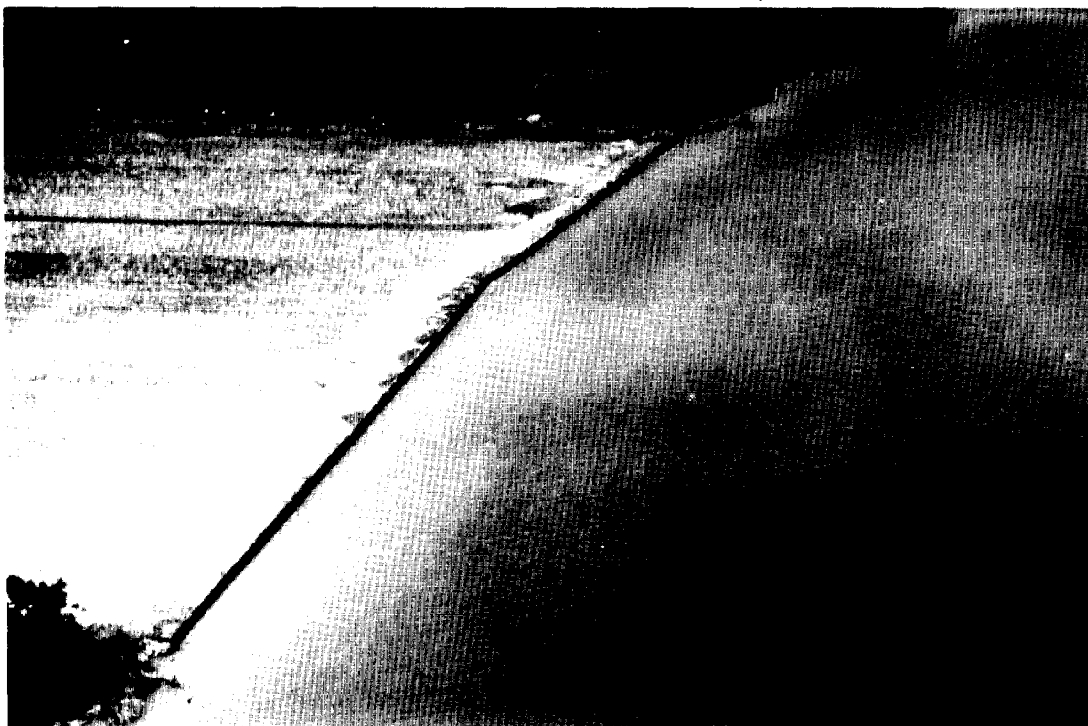
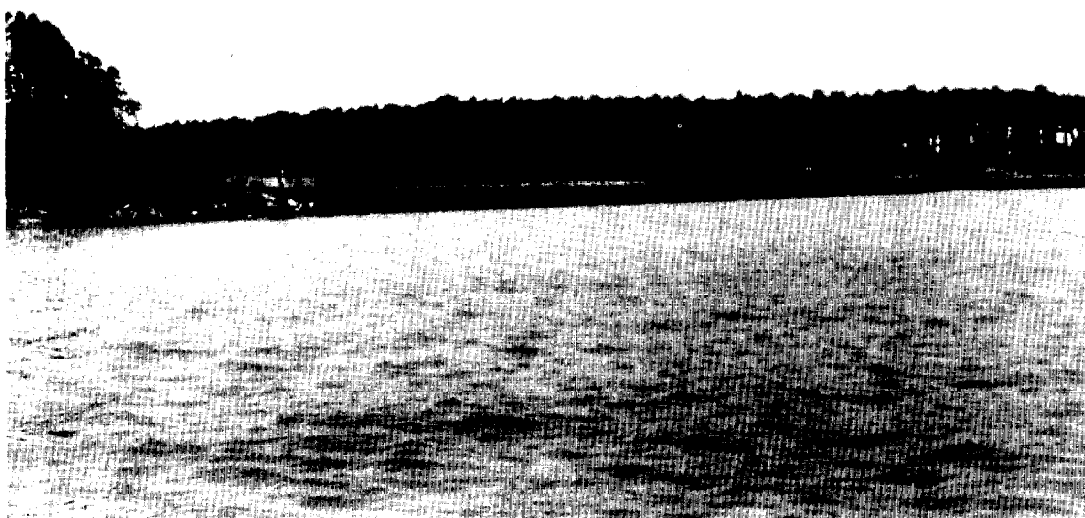
CASE 8 A TIMBER BULKHEAD ON ASQUITH
ISLAND IN THE HONGA RIVER

Structure was completed in 1976 at a labor cost of \$38.92/ft. All materials were provided by the property owner at an unknown cost. The historical rate of erosion at the site was 3.5 ft./yr. from 1848-1932. Bulkhead consists of 10-12 inch diameter pile, 12 ft. in length, on 9.5 ft. centers; 2X10 in. tongue-in-groove sheet pile, 10 ft. long; and deadmen with 3/4 in. galvanized tie rods on the landward side. Asphalt coating on top of piling is in poor condition. No filter material was used. At least one patch has been applied to prevent loss of material through the wall. The structure is bordered by an eroding headland on one side and an eroding shoreline on the other.

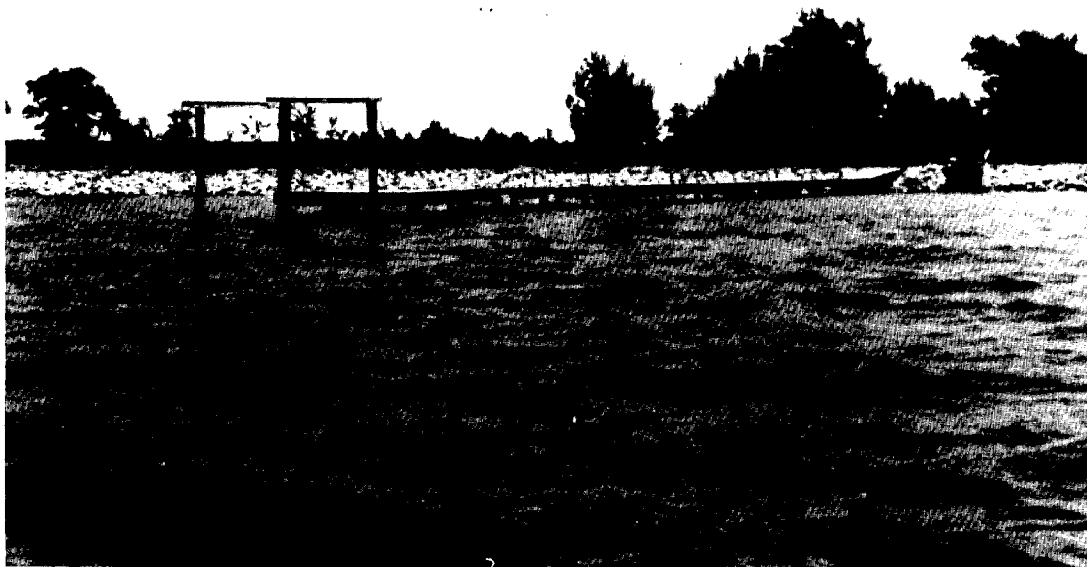
CASE 11 A STONE REVETMENT IN BRANNOCK BAY

Structure was completed in 1975 at a cost of \$25.00/ft. The historical rate of erosion at the site was 4 ft./yr. from 1847-1942. Stone revetment, on a 2.5:1 slope, consists of 250-1000 lbs. stone in a 2-3.5 ft.-thick armor layer. A 3 ft.-wide splash apron was also installed. This structure is in generally good condition; but, there is active flanking erosion alongshore, as evidenced by a 4.3 ft. scarp in the adjoining exposed clay bank.

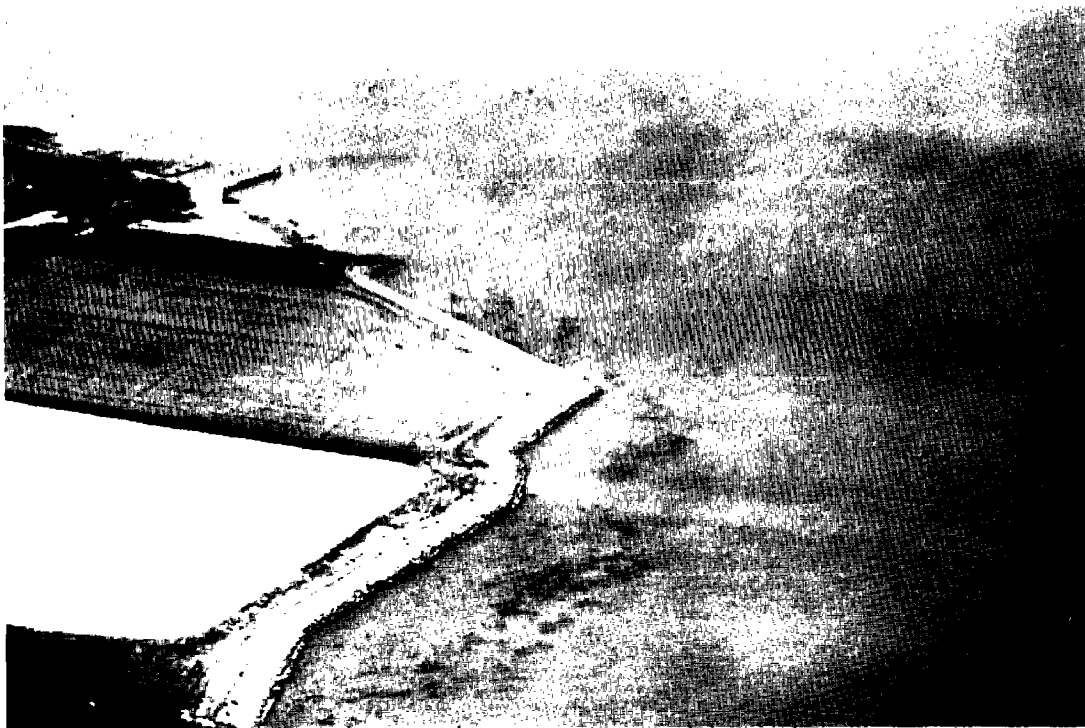
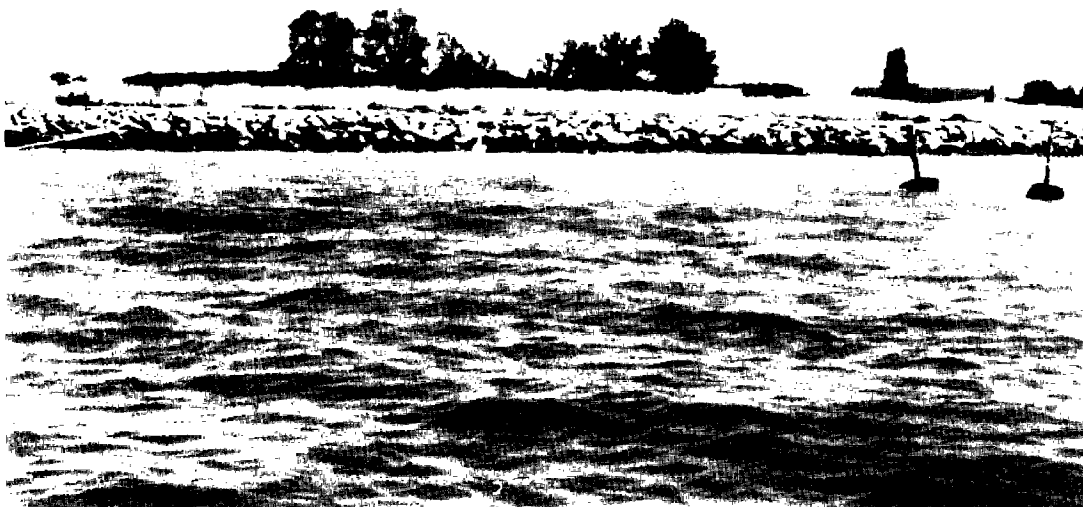
CASE 12 A STONE REVETMENT ON THE SOUTH
SHORE OF THE CHOPTANK RIVER

This structure is in generally good condition. The ties located offshore appear to have been used in a breakwater consisting of regularly-spaced pilings which held the tires. Automobiles and an old cement truck were also placed in the nearshore to control erosion.

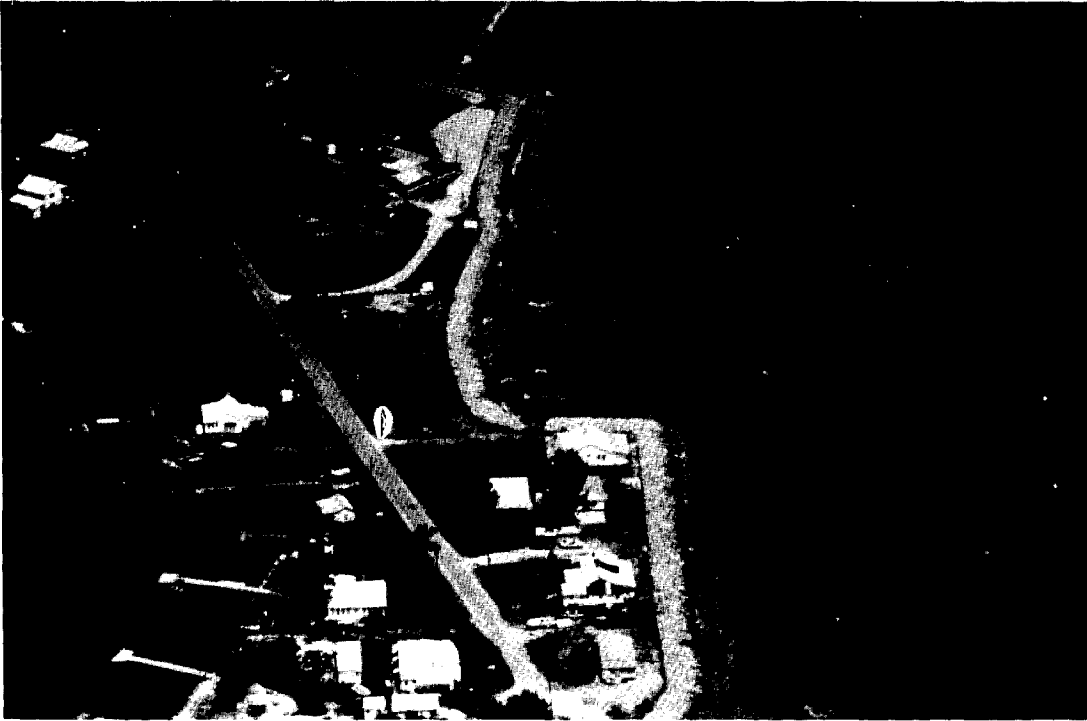
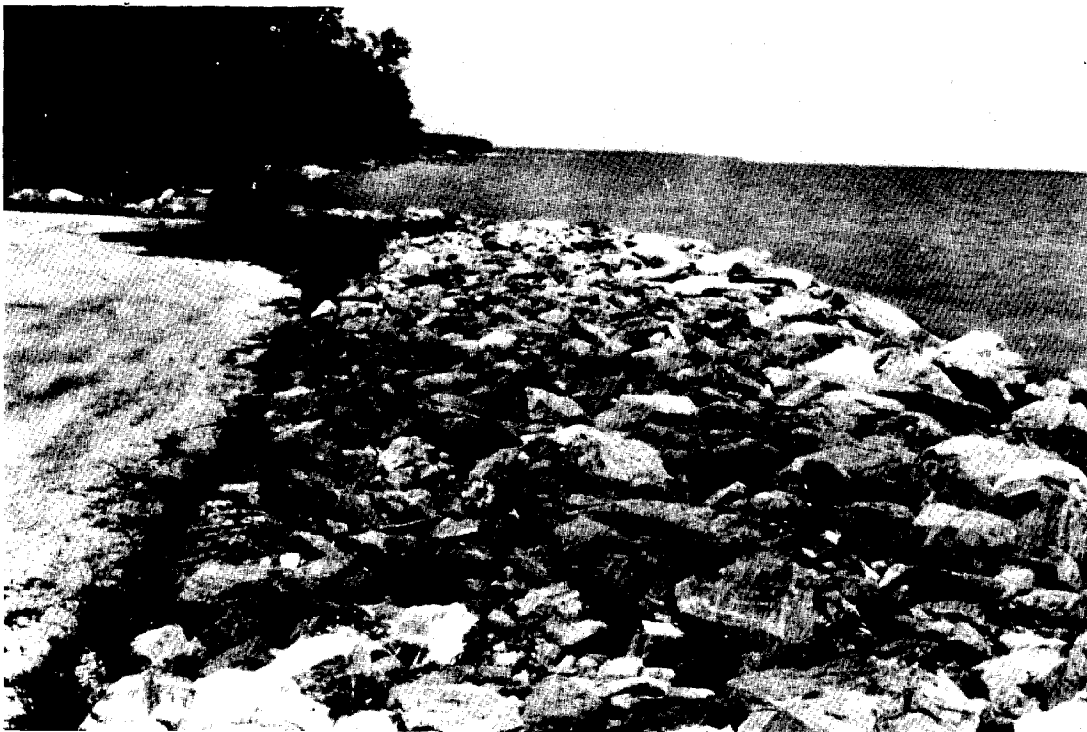
CASE 13 A STONE REVETMENT NEAR POINT
LOOKOUT

This structure is in generally good condition. There is a receding shoreline alongshore to the north of the structure. Eighty-five feet of shoreline recession has occurred there since the structure completion date.

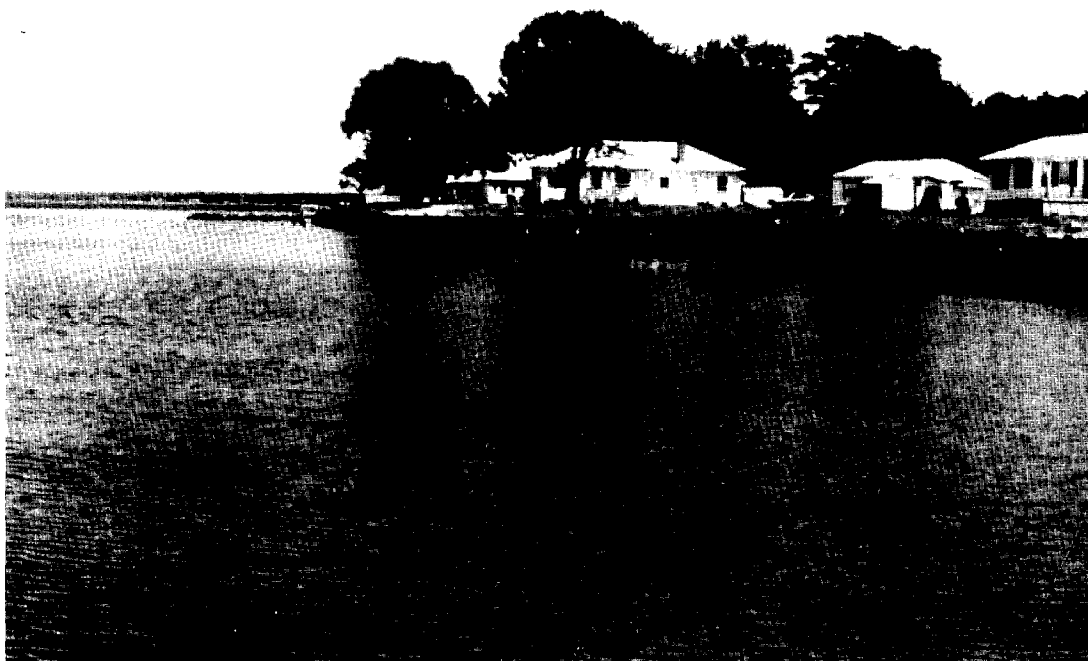
CASE 14 A TIMBER BULKHEAD AT TALL TIMBERS
ON THE POTOMAC RIVER

Structure was completed in 1976 at a cost of \$112.19/ft. The historical rate of erosion at the site was 1.5 ft./yr. from 1868-1968. Bulkhead consists of a wooden sheetpile with an offshore batter pile. Two stone groins (not part of this project) are trapping small amounts of sand, but no beach exists in front of the bulkhead. One of these groins, 80 ft.-long, was added in 1979 at a cost of \$156.00/ft. to act as a breakwater intended to reduce splashover. The bulkhead is in generally good condition. There is evidence of splashover at the site, and the bulkhead has flanking erosion alongshore at one end.

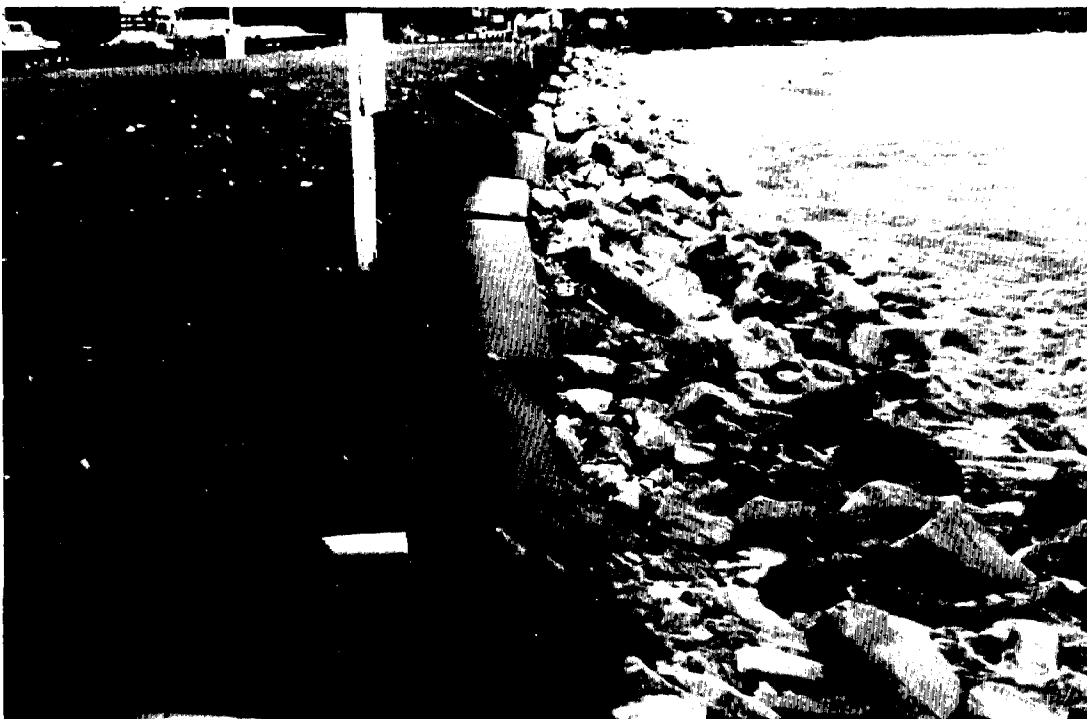
CASE 18 A STONE REVETMENT NEAR THE
BAY BRIDGE

This structure is in generally fair to poor condition. Parts of the structure failed during Tropical Storm David in early September 1979. The wall still provides some protection to the property though.

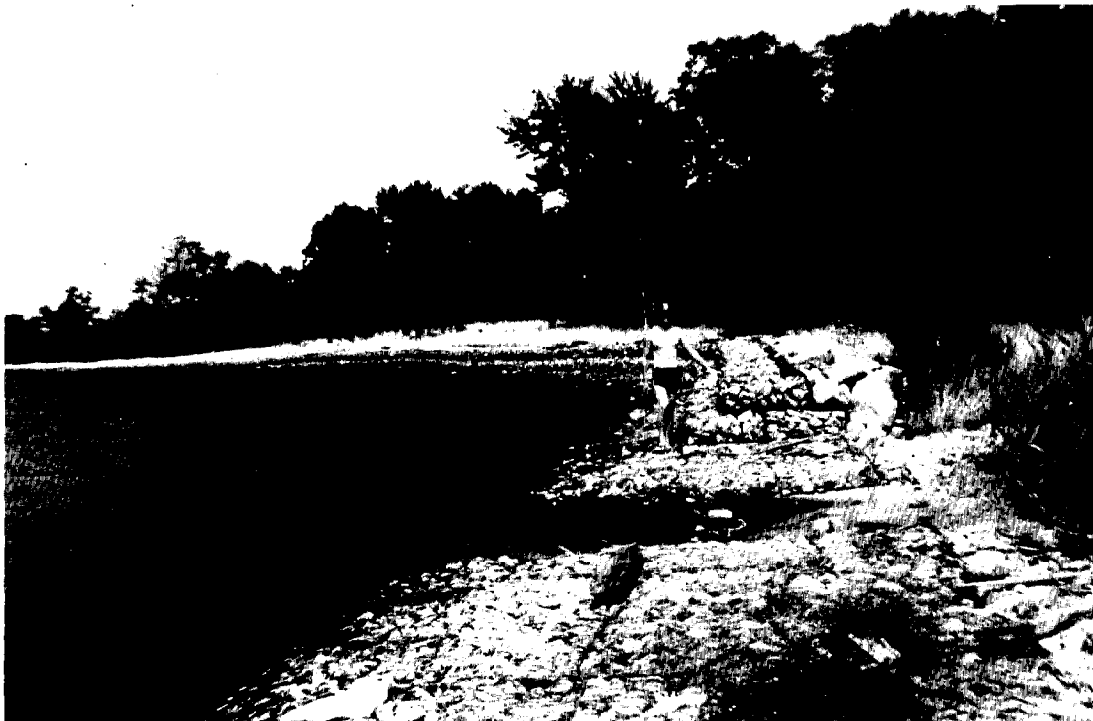
CASE 19 GABIONS AT THOMAS POINT PARK

This structure is in generally good condition. However, a number of the gabions in the base layer are failing. The baskets corrode when the plastic coating is abraded; and, as holes form, the wave action washes out the stones. The baskets have no structural strength without the stone.

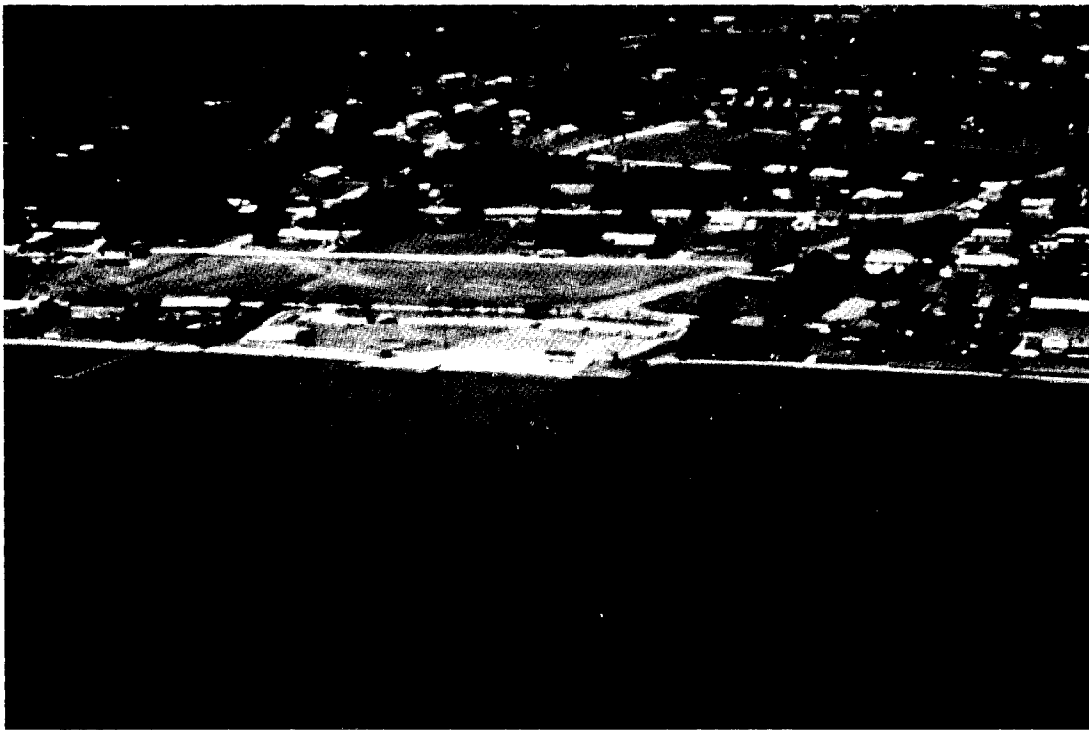
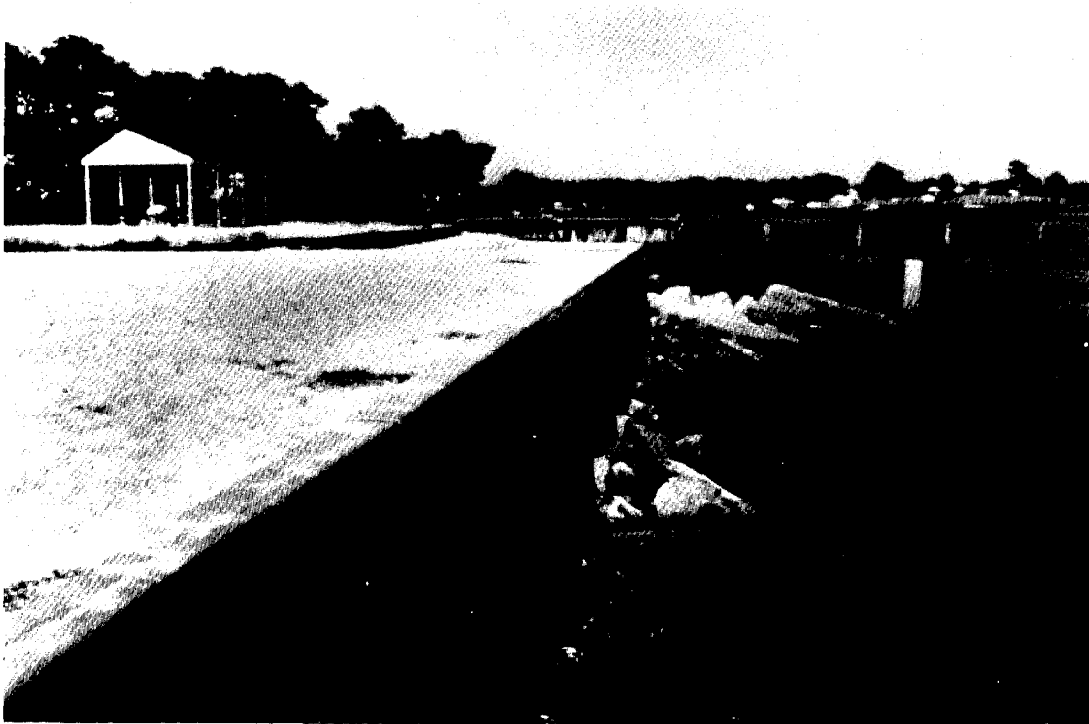
CASE 20 AN ALUMINUM BULKHEAD AT HILLSMERE
SHORES

These structures are in generally good condition. At both structures, grass is growing offshore, and is stabilizing the nearshore bottom.

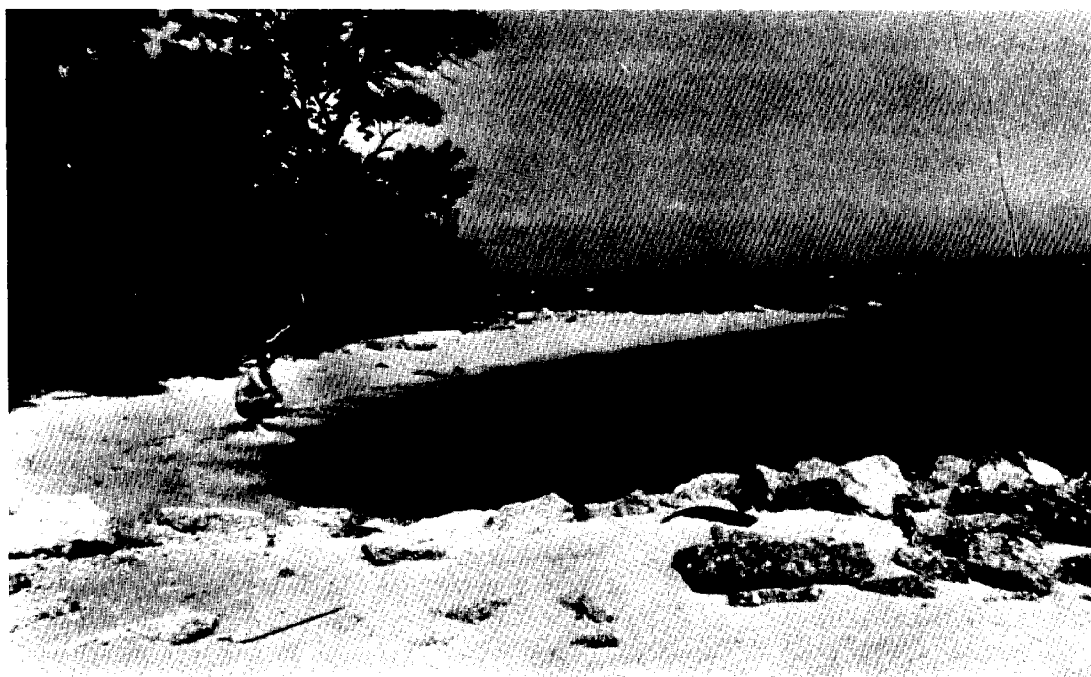
CASE 23 A TIMBER BULKHEAD WITH RUBBLE
 GROINS ON THE LOWER SOUTH RIVER

Structure was completed in 1970 at a cost of \$48.70/ft. The historical rate of erosion at the site was 1.5 ft./yr. from 1847-1970. Structure consists of timber bulkhead which is angular in planform. To the south alongshore, the neighboring property has installed several 8 ft.-long concrete pipes laid out perpendicular from the shoreline to act as groins. To the north alongshore, 3 concrete rubble groins are present. The bulkhead is in generally good condition. The rubble groins are extremely effective in trapping littoral sediments, and pocket beaches are present between the groins. The concrete pipe groins have trapped some sediments to form a smaller beach, but these structures are not sand-tight.

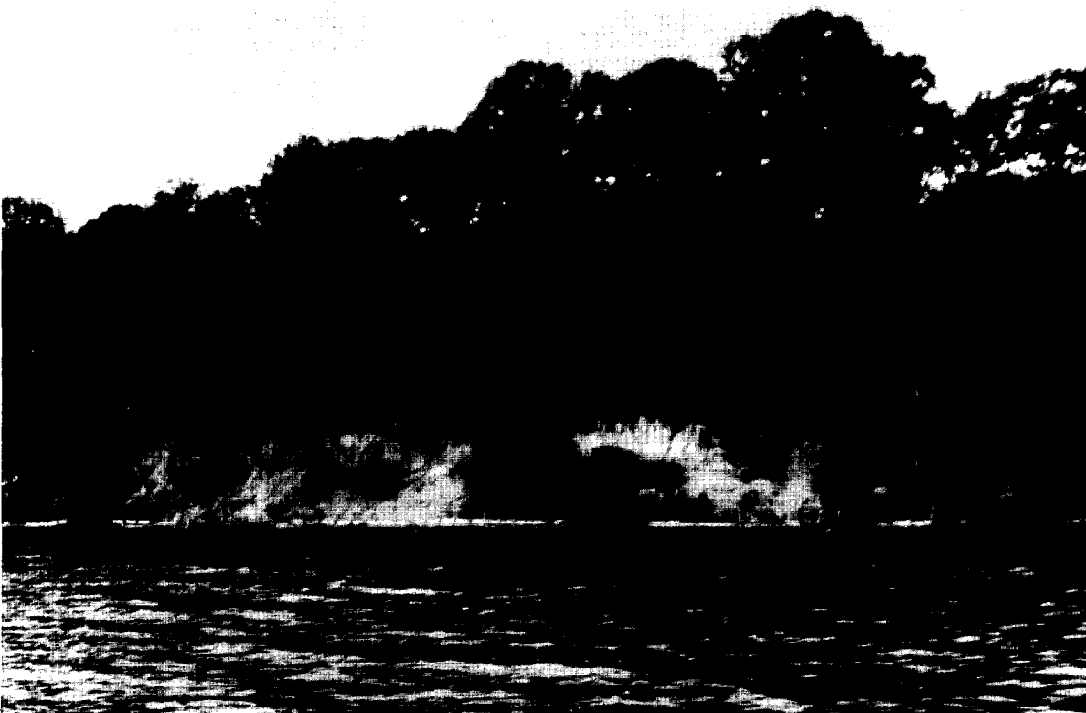
CASE 24 LONG POINT

Relics of the bulkhead structure provide evidence that the bulkheading utilized 4 inch piles with 2 inch x 12 inch, and 2 inch x 7 inch planking, 2 to 5 planks high. Presently this structure is having no beneficial effect on the shoreline.

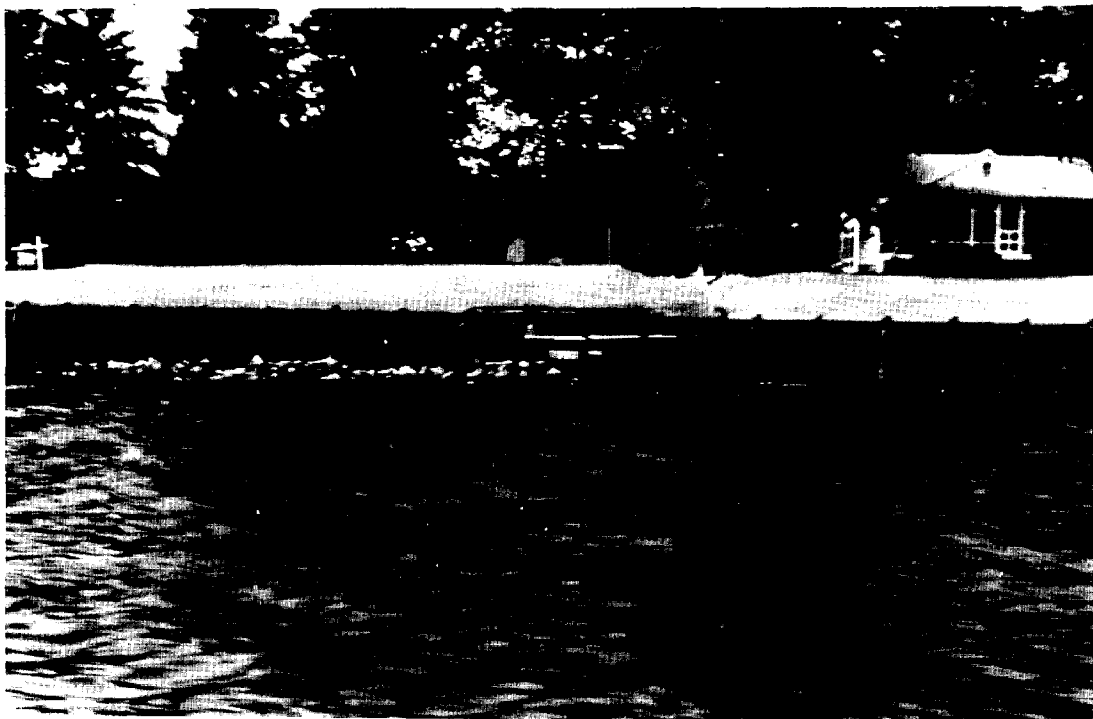
CASE 26 A TIMBER BULKHEAD AND STONE
 REVTMENT ON MIDDLE RIVER

Structure was completed in 1978 at a cost of \$115.60/ft. The historical rate of erosion at the site was about 2.5 ft./yr. from 1847-1936. Timber bulkhead consists of 3 in. x 10 in. tongue-in-groove sheetpile, and walers 6 in. x 8 in. The planform of the wall is S-shaped. A 10 ft.-wide rip rap toe has also been installed at the base of the structure on the seaward side. This structure is in generally excellent condition. The wall is constructed to extend very high up the bank face and limits splashover from the worst wave conditions. The rip rap at the toe of the structure provides added protection against wave scour and erosion of finer-grained sands and silts of the natural bottom.

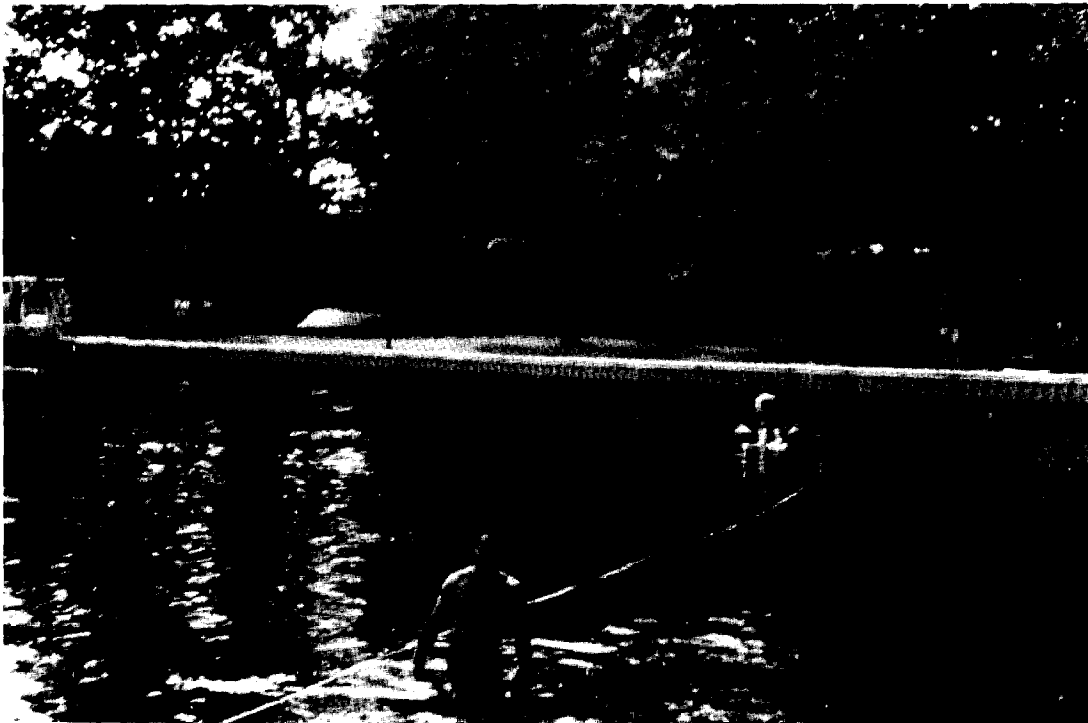
CASE 28 ALUMINUM BULKHEAD ON BACK RIVER

Structure was completed in 1974 at a cost of \$70.00/ft. The historical rate of erosion at the site was about 2.5 ft./yr. from 1846-1944. Structure consists of corrugated aluminum sheetpile 0.125 in. thick and 10.1 ft. long. A deadman anchoring system is connected to the wall by tie rods 3/4 in. in diameter and 14 ft. long. This structure is in generally good condition. There is evidence of splashover at the site, but there are no problems with flanking erosion alongshore since the wall connects with other vertical structures on both ends.

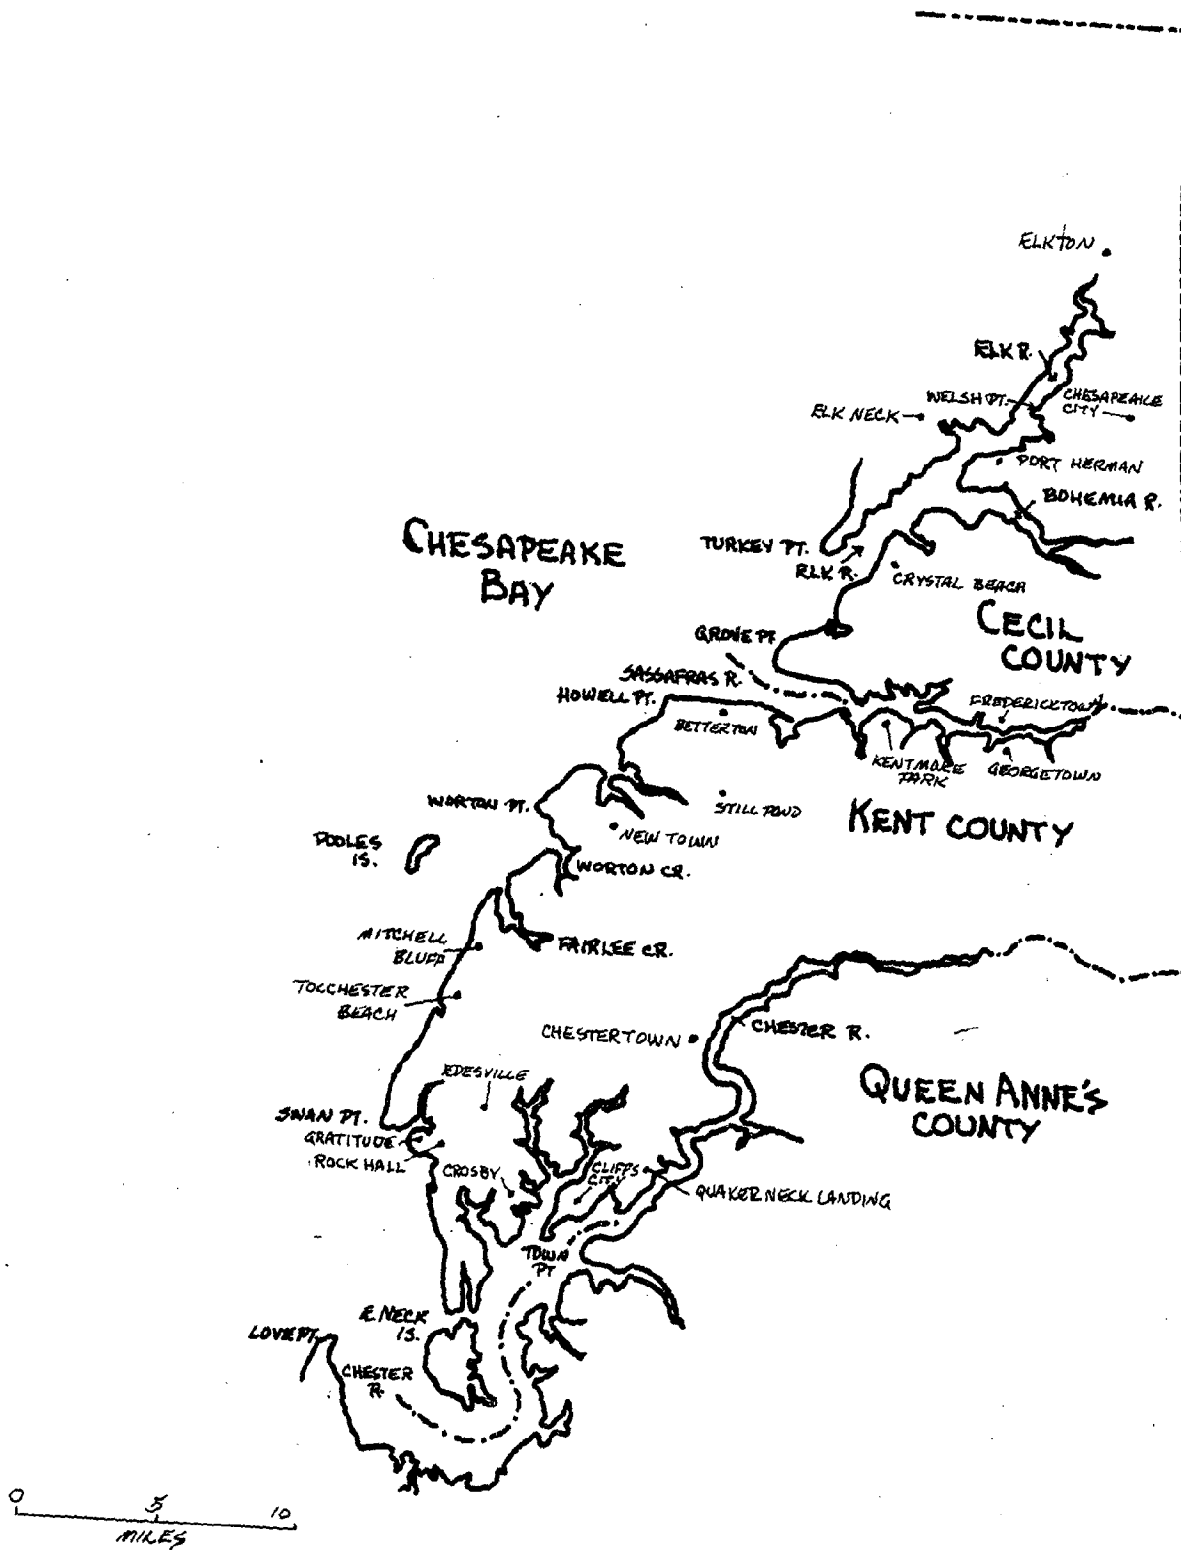
Figure 2.10

Next Pages: Figure 2.10. Shoreline along Eastern Cecil County and Kent County.

This area of the northern Chesapeake Bay shoreline (Figure 2.10) contains portions of Cecil County and Kent County. The sections below present a brief physical description of the shoreline and coastal processes, followed by a discussion of the case studies which were selected from this area.

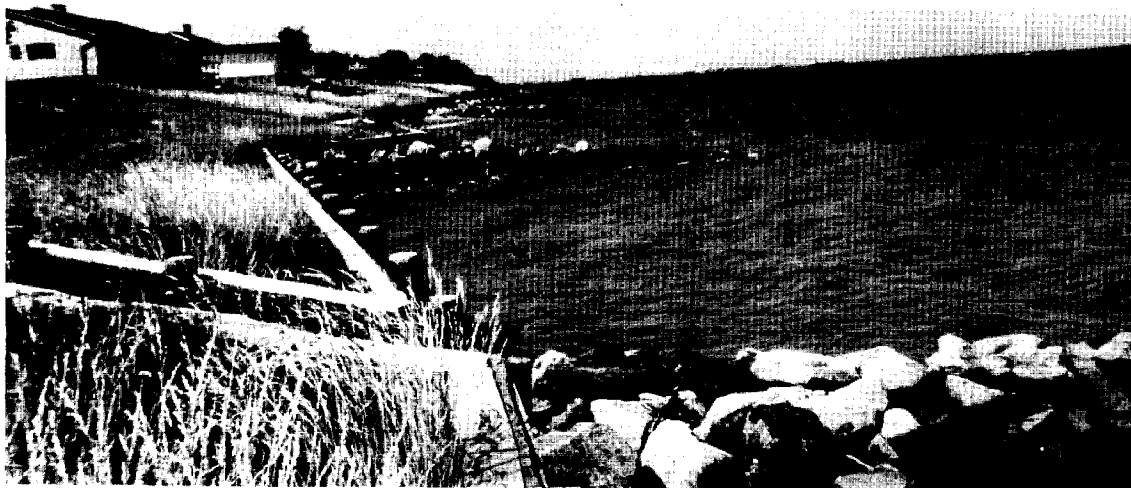
CASE 35 A TIMBER BULKHEAD ON KENT ISLAND
WITH STONE GROINS

One stone groin existed prior to the construction of the rest of the structures. The original timber bulkhead and one groin were constructed in 1973 at a cost of \$63.29/ft. and \$35.80/ft., respectively. In 1976, 493 ft. of timber bulkhead and two stone groins were added at a cost of \$79.35/ft. and \$54.91/ft., respectively, and the two existing groins were refurbished and extended at a cost of \$39.92/ft. Timber bulkheads consist of tongue-in-groove sheeting, and piles are spaced on 7.5 ft. centers. Groins were constructed of 400-800 lbs. stone on a 1.5:1 slope with a 3 ft.-wide crest. These structures are in generally good condition. No beach sand was observed at the site in the summer of 1980. There is strong wave activity in this area, and the wave crests were observed to reflect against the vertical bulkhead. Bulkheads to the north alongshore are being forced landward by waves, and backfill is being lost through the bulkhead wall. There is also evidence of wave overtopping and splashover at this site.
